INTRODUCTION

In the late 1930s and early 40s, the Civilian Conservation Corps (CCC) worked in Pokagon State Park and built many of the existing structures. Included in their work at the park was the construction of three fishery ponds that were intended to raise fish for nearby Lake James. Over time, the vegetation in the area grew rapidly, and without annual maintenance, the site became overgrown and unrecognizable. Each year all three ponds fill with water from snowmelt and springtime rainfall, but by the end of the summer the ponds are almost completely dry. The park wishes to restore these ponds to their original condition through a complete analysis and redesign of the site. These ponds are located just north of the Potawatomi Inn and have great potential to host a serene and thriving ecosystem again.

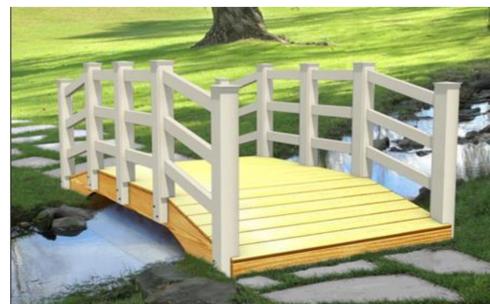
The client informed our team that they would like to add a pedestrian bridge to the site. The bridge will be installed over a channel that connects two of the ponds. Adding a bridge to the design adds aesthetic value as well as an opportunity for visitors to get a close view of the ponds. A prefabricated bridge was selected from a supply company, and we performed a complete structural analysis to ensure that it was safe.
