## INTRODUCTION

In 1935, three ponds were excavated and constructed for a fish hatchery that fed Lake James. The ponds are located north of the Potawatomi Inn in the southwest corner of the park. The construction of the ponds included inlet piping, overflow piping, and control structures between the ponds. The ponds have two water sources, which include surface runoff from the north and a drainage area to the west of the ponds that are connected via a drainage pipe. However, the ponds do not retain water throughout the year. Currently, the ponds are unattractive with overgrown plants and trees.

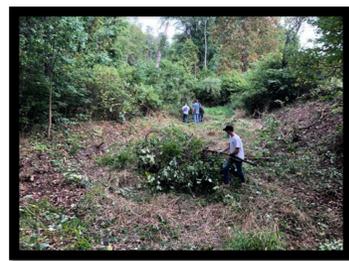
Grubbing had to be completed before any field work could be started. Surveying, soil boring, water tracing, and water quality testing was completed during the project. A topographic survey was completed to generate a contour map in AutoCAD. The contour map allowed elevations and slopes to be determined. Soil borings were taken to further analyze the soil in the lab. Water tracing was done to determine the drainage area. Water quality testing was also performed at the site to ensure the water was adequate for aquatic life. After the water testing was completed, it was determined that the on-site water is safe for fish.

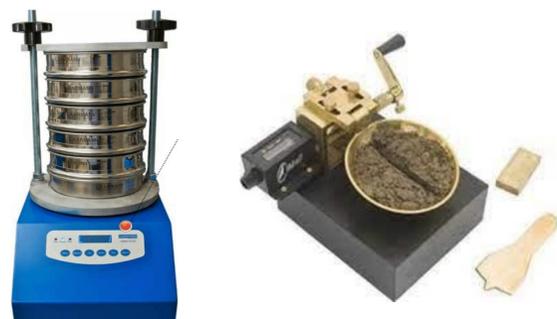
In order to get a better understanding of the soil types and quality of water present in the ponds, several tests were completed both in the field and in the lab. Water quality data was compared to the Fawn River Fish Hatchery in Orland, Indiana. All results were within the desirable range, and it was concluded that the ponds could support aquatic life if desired. After soil testing was completed, we determined that the bottom of the ponds consisted of lean clay, whereas the banks consisted of poorly graded sand.

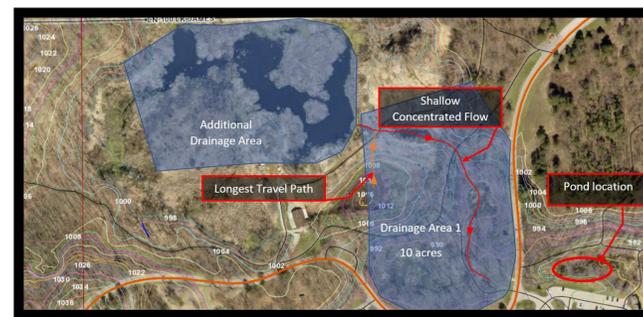
An important aspect of the design was determining the amount of water getting to the ponds. The TR-55 method was used to estimate the amount of runoff to these ponds. It was determined that not enough runoff is flowing to the ponds for a permanent pond. A second water source would be needed for a permanent pond.

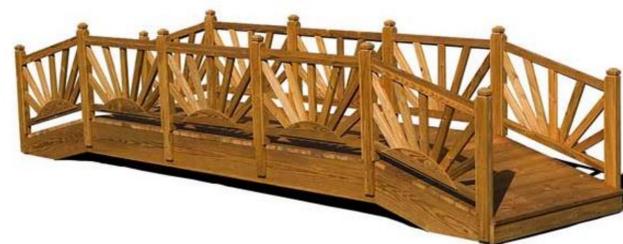
Pokagon would like to have a bridge in the middle of the two existing ponds. Prefabricated bridges were found on Fifthroom.com, and we decided to implement the Treated Pine Sunrise Bridge into the project.

This timber bridge will span 10 feet in length and would be an excellent location for event pictures at the park such as weddings, proms and field trips. Analysis of the bridge was completed using the National Design Specification for Wooden Structures and the LRFD Guide Specification for Design of Pedestrian Bridges to calculate the weight capacity of the bridge.

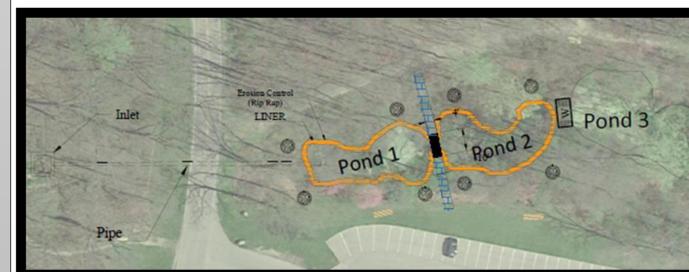
A second option is to develop permanent ponds. Using the hydrology information gathered, we determined that it will likely be necessary to include a liner to the edge of the pond to prevent excess infiltration which would occur on the edge of the ponds. Also, a second water source would be required to maintain water within the ponds without any problems with the dry season. We also recommend replacement of the catch basin and piping leading from the inlet to pond 1. A headwall will be needed to reduce the flowrate out of pond 2 which will increase the water level in pond 1 and pond 2. Like the seasonal pond design, accommodations, such as rip rap, clearing, benches, a bridge and new vegetation is recommended for this permanent design as shown below.
