## INTRODUCTION

Wohlert Street in Angola, Indiana functions as a major collector road and connects much of the city's industrial park area. Additionally, a residential development on the north end of the roadway segment is underserved with pedestrian connectivity. The City of Angola requested an evaluation of the existing alignment, drainage, pavement, and intersections along the section of Wohlert Street shown in the figure below.

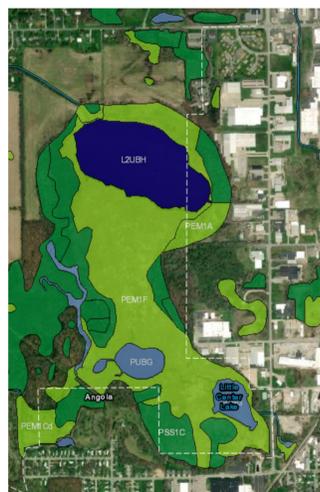
The existing road is an asphalt paved two-lane road, with one lane in each direction. There is no curb and gutter for this section of Wohlert. The established speed limit for this road is 35 miles per hour. The existing drainage system consists of ditches along both sides of the road which flows generally to the south toward an existing wetland, which is highlighted below in green. The blue area is an existing small lake.

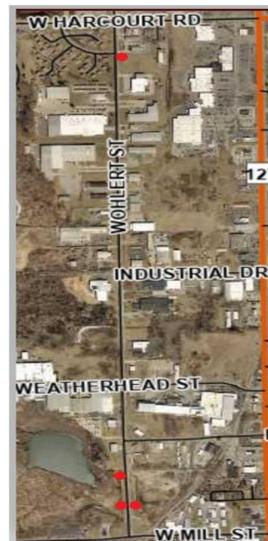
We performed 5 feet deep soil borings at 4 separate locations and obtained samples for geotechnical lab testing to understand the characteristics and structure of the existing soil. The boring locations are shown below in red circles adjacent to the road. The soils generally consisted of clay soils (A-6).

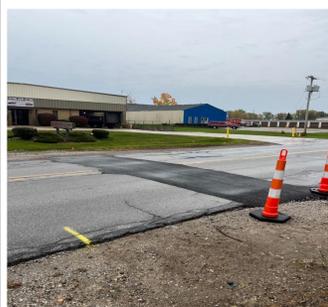
We evaluated the existing pavement condition using the Pavement Surface Evaluation and Rating (PASER) Manual method. We identified multiple areas with issues including raveling, longitudinal and transverse cracks, and alligator cracking. Additionally, we identified initial longitudinal cracking near the pavement edge and alongside patches. The assessment revealed PASER rating scale of 4. Based on this rating, full-depth reconstruction is not needed. Rather, a 2.5-inch thick non-structural overlay with some full-depth patching and milling near intersections will be required. Photos of some of the pavement damage areas are shown below.

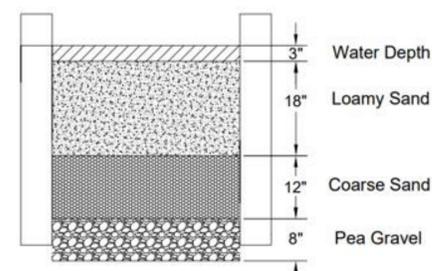
The current runoff from the road flows into existing grass ditches. Improvement methods such as concrete curb and gutter and a pipe system were initially proposed. However, we recommend that a green gutter system be used for this project. The green gutter design follows the San Mateo Guidebook Chapter 2 "Design Strategies for Green Streets and Parking Lots" specifications. The filtering beds consist of 18 inches of Loamy Sand, 12 inches of Coarse Sand, and 8 inches of Pea Gravel, with an embedded 8 inch perforated pipe.

Runoff which flows into the green gutter only partially infiltrates into the natural subgrade. The remaining water will accumulate in the voids of the media and drain into the two new bioswales on the west side of Wohlert Street. The southwest bioswale, measuring 40 feet by 20 feet, will capture runoff from the southwest half of the project. Simultaneously, the northwest bioswale, spanning 90 feet by 18 feet, receives runoff from the northwest side of the green gutter. The image below shows a typical cross-section of a bioretention swale.
